Potential damage to residential building due to adjacent surcharge fill loading-case studies in Surabaya, Indonesia

D Tjandra^{1,2}, H Sugiharto¹, J Buntoro¹ and P S Wulandari¹

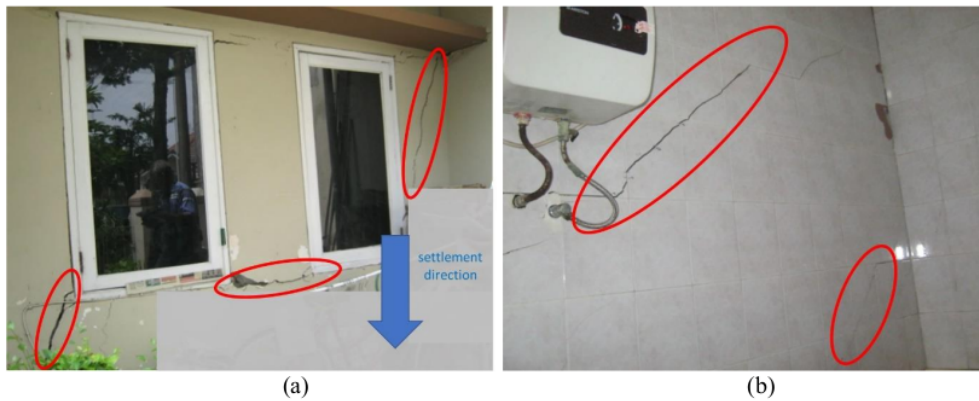
The damaged house as Case A, as an existing building, is located on the right side of the new building construction work. This project was doing construction a new house building with surcharge fill of 1 meter in height. From visual observation, it was found that there were some cracks in the walls in several rooms. A sizable crack was found in exterior walls of the Case A house as shown in Figure 1 (a). From the crack pattern, it was an indication that the left side of the existing building has settled. In addition, cracks were also appeared in wall in a room, as shown in Figure 1 (b), which is located on the left side of the Case A house.

Figure 1. Diagonal crack on wall.

Based on the damage analysis, for both cases damaged houses in this study, it was found that houses damages were potentially induced by adjacent surcharge fill loading work. For both cases (Case A and Case B houses damage), it was analyzed that foundation retrofitting was required to strengthen the existing building foundation. Retrofitting was carried out prior to repair works, in order to terminate continued settlements of the building and to prevent cracks in building. Further settlement may develop more than a year caused by consolidation, especially in clay layer deposit, which may take several years to complete the consolidation. The proposed retrofitting method in these cases study was in the form of underpinning by a strauss pile foundation. Pile was designed with a diameter of 30 cm within a depth of

6 meters located at several points where settlement occurred. After retrofitting works, following repair works were conducted; floor leveling with sufficient compaction, ceiling leveling, repair of cracks in the walls, repair of doors and painting of walls. The cost of repairs and retrofitting for an existing house in Case A was IDR 153.94 million (IDR 1.97 million/ m²) and for a house in Case B was IDR 334.3 million (IDR 2.37 million/ m²). From this study, it was shown that total cost of repair and retrofitting works reached 50% of the total cost of building a new house, which is around IDR 4 million / m².

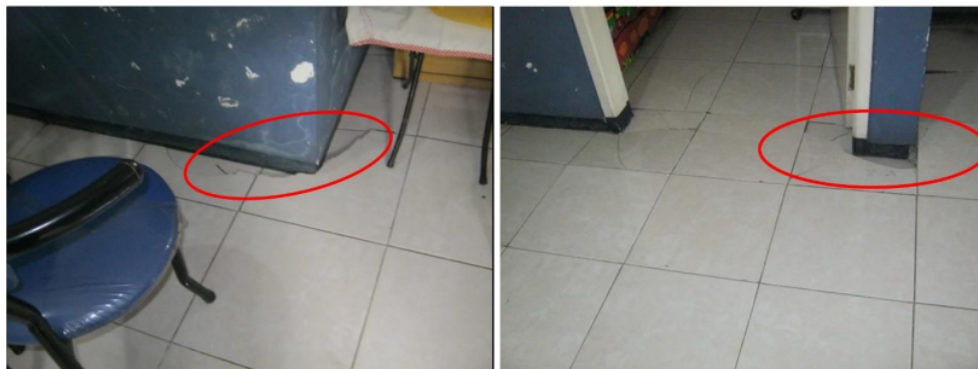
There were some obvious signs of differential settlements, including cracks in the floors and doors are hard to open and close. The cracks in floors were clearly visible in the living room area as shown in Figure 2. From the form of cracks in the ceramic floor, it shows that differential settlement occurred in between the left and right sides of the Case A house. The differential settlement was recorded at 7 cm with water level measurement.

Figure 2. Settlement on living room.

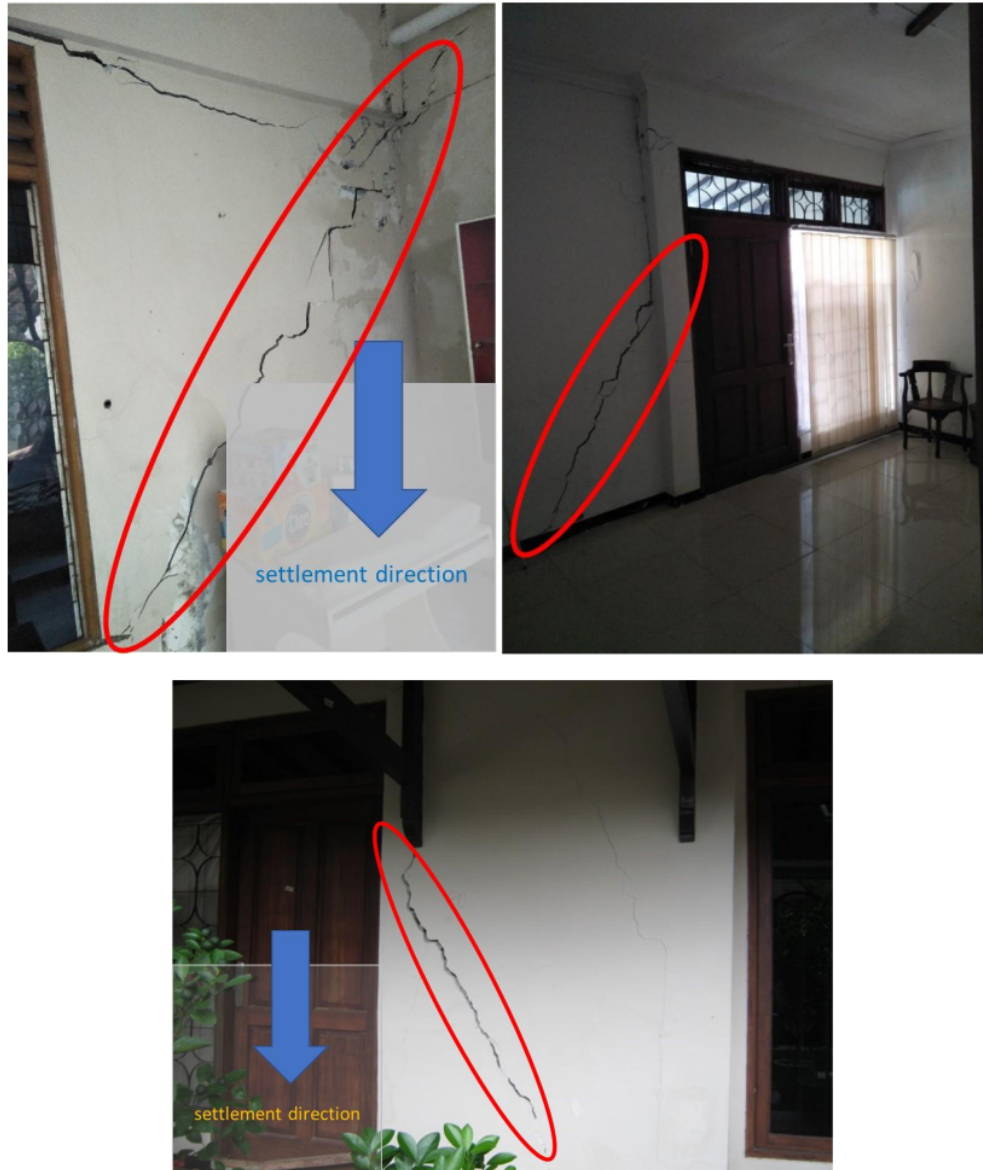
The damaged house as Case B, as an existing building, is located on the left side of the new building construction work. It was measured as 1.3 meters of ground elevation differences between two adjacent buildings. It was due to the new building was built on surcharge fill with height of 1.3 m. As a result of the additional load on the right side of the building, there is a greater amount of settlement on this side compared to the left side of the building. Diagonal cracks on wall also indicated a differential settlement in building. These cracks occurred on the exterior walls, the walls in the living room of the Case B house (Figure 3).

Figure 3. Diagonal crack on wall.

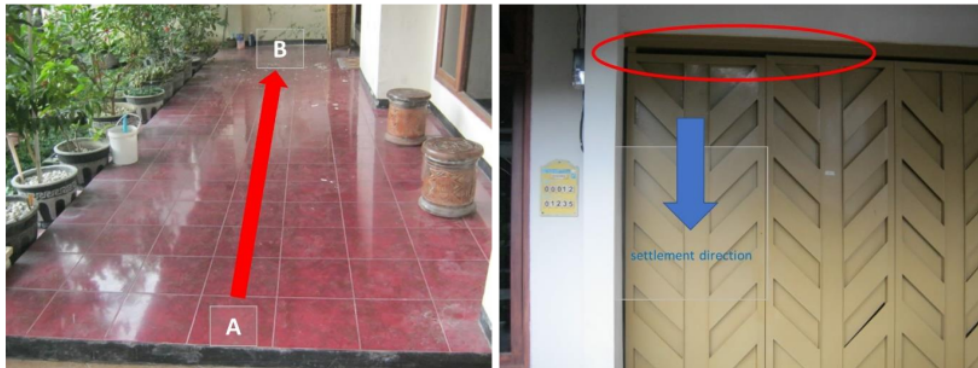
Due to the additional load of surcharge fill, there was a settlement on the right side of the existing building which caused a slope on the floor. The difference floor elevation between the left side and the right side of the Case B house was about 8-10 cm by water level measurement. It is shown between point A and B in Figure 4. Differential settlement also resulted damage to garage doors and some room

doors. The doors were hard to open and close. Pictures of damages due to differential settlement is shown in Figure 4.

Figure 4. Differential settlement.

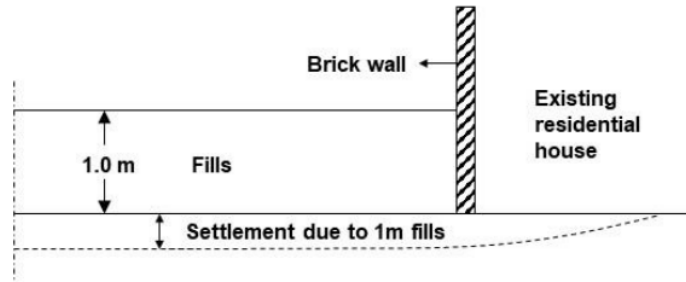
Regarding number of damages that occurred in Case A and Case B houses, the main causes of wall cracks and floor slopes were due to differences in settlement in the house, which is uneven settling between a side and the opposite side of building. Figure 5 shows the pattern of settlement due to adjacent surcharge fill loading works. In clay soils, the largest settlement will occur under the fill. Based on the settlement scheme in Figure 5, it can be explained that the settlement of the soil layer near the brick wall is greater than the settlement that occurs at a location farther from the brick wall in existing residential house. This will result in differential settlement of existing buildings in that location. The differential settlement in buildings of the observed houses in this study was recorded about 7-10 cm.

Figure 5. Prediction settlement due to fill.
