Available online at www.sciencedirect.com

ScienceDirect

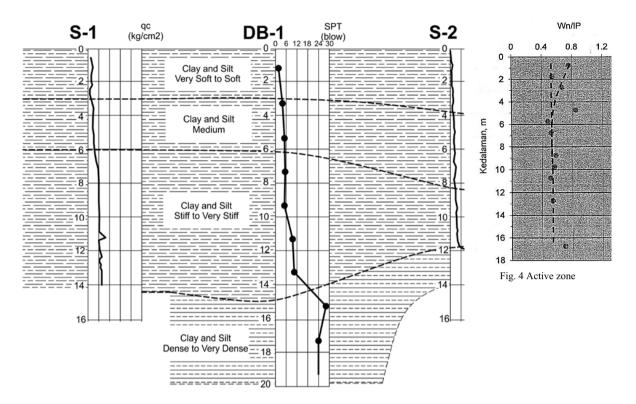
Fig. 2 Typical piled foundation
