**Procedia
Engineering**www.elsevier.com/locate/procedia**The 5th International Conference of Euro Asia Civil Engineering Forum (EACEF-5)**

Authenticity principle in conservation of De Javasche Bank of Surabaya: Materials, substance and form

This paper aims to discuss the application of the notion of authenticity principle in the conservation work of De Javasche Bank building in Surabaya in term of form, materials and substance. This heritage building was built in 1910, and it has been unoccupied and dilapidated for decades, subsequently in 2010, the owner, Bank Indonesia began the conservation work of the building. Data regarding form, materials and substance of the building were collected from field observation during the conservation work from 2011 to 2012, and collected from the Conservation Plan prepared in 2009. Based on the data, the principle of tangible authenticity is tested based upon scientific method to test material authenticity, and through a good knowledge of the typology of objects such as form of the building and elements of the building, materials and substance of the roof and floor tiles, plasters and paints, and the ornaments. The results show that to achieve

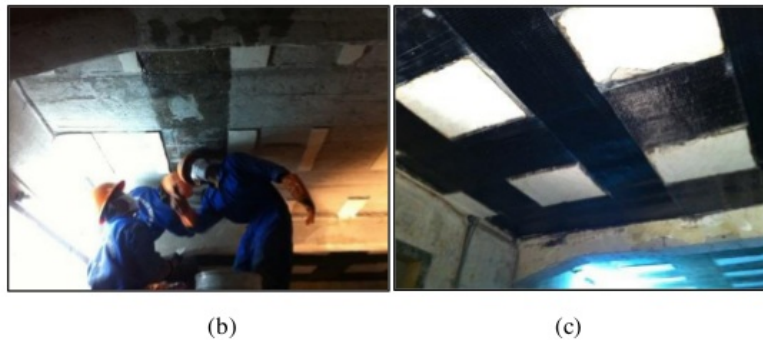
Fig. 3. (a) bottom slab strengthening; (b) beam strengthening; (c) installing fiberwrap on the slab.

For a historic building such as De Javasche Bank, the structure of the building has to be stable to function for an adaptive reuse and for a long term. Hence, the structure of the building has to be reinforced for its beam and slabs at the first and the second floor based on the structural analysis report. In order to keep the original form of the structure, fiber-wrap system was used to reinforce the beams and plate of the first floor, and due to limited funding and its uses only for mechanical, electrical and plumbing systems, the second floor was not reinforced, see Fig. 3.

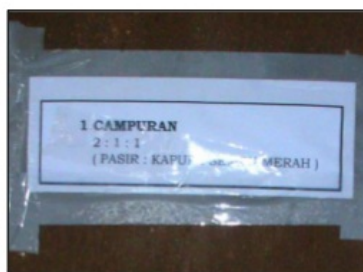
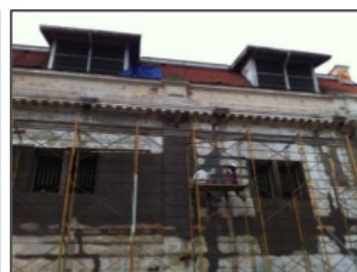
Fig. 6. (a) a result of the laboratory tests of the original plaster mixture ratios; (b) a sample of new plaster with the original ratios; (c) the new plasters were applied

Most of the exterior and interior plaster of the buildings was cracked that caused range from water damage to structural problems. Historically, plaster of old building is made of a lime-putty mixture or a combination of lime putty and gypsum. Repairing the plaster to the original material and substance, it is first identify the historic plaster so that it can be matched. Material samples of the plasters were taken and sent to a laboratory to be identified, namely Balai Besar Konservasi Peninggalan in Borubudur, Yogyakarta. The plaster was identified as lime based plasters, sand and red brick blended with limestone in 2:1:1 ratios, Fig. 6a. Based upon this lime plaster ratios, a sample of new plaster was created for evaluation before applying them to all surface of walls, Fig. 6b and 6c.

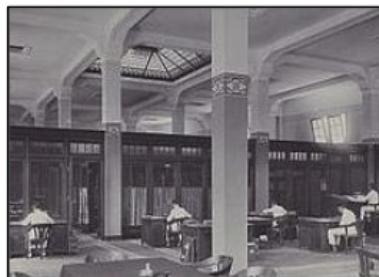
Fig. 7. (a) the original ornament on the columns. Source: Bank Indonesia; (b) the original ornaments was revealed; (c) the original ornaments was recovered.

According to the old photos, there were ornaments on the column and wall, and based on the peeling of the existing paint layer by layer on a column, then the original ornament in term of form and color was revealed, subsequently the original ornament could be restored according to the original one, see Fig. 6. Similar to the lime based plaster, the original paint is lime based paint, and to seek for the original color the paint on the wall and columns were peeled layer by layer to the last layer as the original color of paint, see Fig. 8. In term of the substance, the breathable paint was used based on the knowledge of the typology of paint that used for historical buildings during the colonial period. The paints have micro-porous characteristics, letting walls breathe naturally, enables humidity contained in building structures to be quickly released unhindered into the environment, avoiding moisture build up on the walls, and contain no fungicides or chemicals.
