The Effect of Welded Splice with Predetermined Gap of Concrete Spun Pile on The Response of Low Strain Integrity Test

Budi, G.S.^{1*} and Tanaya, L.S.²

Abstract: This paper presents the velocity wave of concrete spun piles with welded splice. The stress wave velocity was recorded using Pile Integrity Test. Two specimens were prepared in the experiment. The first sample was prepared visually no gap between the two end-plates of connected piles, while the second specimen was prepared by inserting 5mm thick steel plate into the splice to create a gap in its connection. The results show that a spike of reflecting stress wave still develops at the splice with and without gap, regardless the splice was welded in full circle. The relatively high spikes of reflecting waves at pile toe are noticed for both specimens with and without gaps. It shows that the full welded splice able to transfer stress wave velocity. A good quality of welded splice can be indicated by the reflecting wave at the pile toe, regardless the reflecting wave development at the splice.

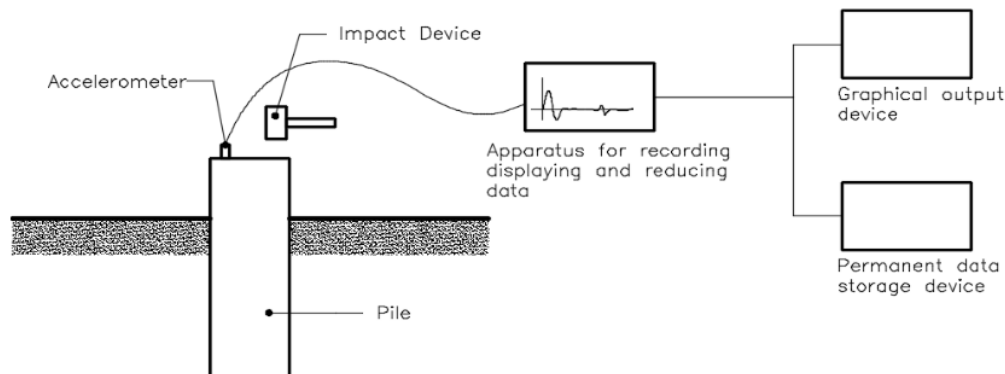
Figure 1. Schematic Diagram of PIT (ASTM D 5882)

6 **Pile Integrity Test (PIT)** is a Non Destructive Test (NDT) technique, where the methods of testing fall into two categories. The first one is **Pulse Echo Method (PEM)**, where pile head motion is measured as a function of time, and time domain record are then evaluated for pile integrity. Secondly, the **Transient Response Method (TRM)** is where the pile head motion and force are measured as function of time, the data are then evaluated usually in the frequency domain. Practically, the PIT referred mostly to **Sonic Pulse Echo Method**, which using an accelerometer and hand held hammer which known as low strain in dynamic testing (ASTM D5882). The schematic diagram of PIT is depicted in Figure 1. Details of the theoretical background and the development of PIT are discussed in various literatures [6-8].

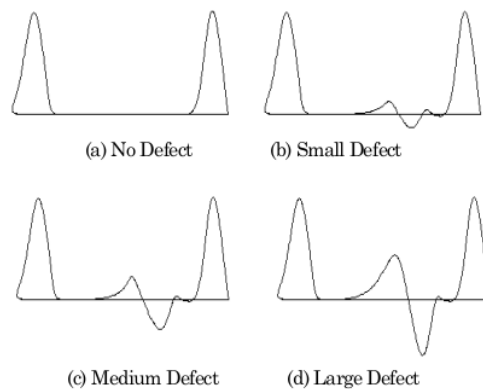
Figure 2. Basic Interpretation of PIT

The recorded PIT Graph is a velocity on time domain function, in which wave propagation mechanics illustrated that the pile impedance can be interpreted based on pile impedance, Z . The interpretation of PIT result can be bias because of the number of unknown variable that caused a change of impedance, such as pile defect, soil resistance, pile splice, in-homogenous material, etc. However, the location and severity of pile defect can be interpreted simply by observing the impedance spike on the PIT recorded graph. The basic interpretation are illustrated in Figure 2. Figure 2a shows that the integrity of pile is good since there is no reflecting wave between the two spikes at the head and toe of the pile. The development of spikes of reflecting wave in the area between two spikes at the head and toe of the pile is an indication of defect at the pile. The smaller the spike the smaller the defect, and vise versa, as illustrated in Figure 2b, Figure 2c, and Figure 2d.

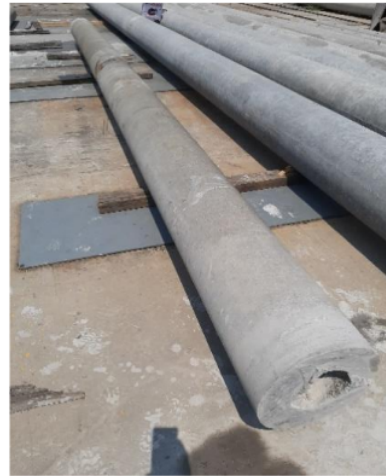
Figure 3. Precast Pile Specimens

The research was performed to investigate the response of recorded stress wave velocity at the welded splice of precast prestressed spun pile diameter of 350 mm using PIT. There were two (2) sets of spun piles connected by welding at its endplates. The splice of the first specimen of pile was welded without any gaps (observed visually) between the two endplates, while the second specimen was prepared with predetermined gap between the two endplates. The gap was generated by inserting a 5 mm thick steel plate. The total length of the specimen was 7000 mm, which was connected in the middle of its length (Figure 3). The pile specimen exhibits concrete strength (f_c) of 42 MPa, 6 PC-bars with diameter of 6 mm, and 6 mm thick steel endplate.

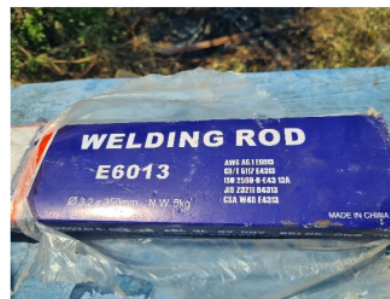
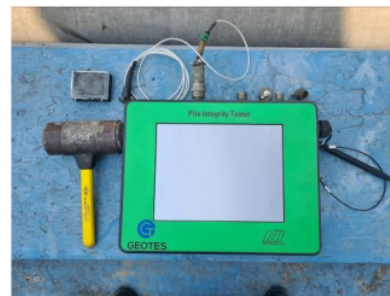
Figure 4. (a) Welding Rod; (b) PIT and its Accessories

The specimen was connected using welding rod type E6013, which has diameter of 3.2 mm (Figure 4a) then tested using low strain integrity apparatus (PIT) as depicted in Figure 4b.

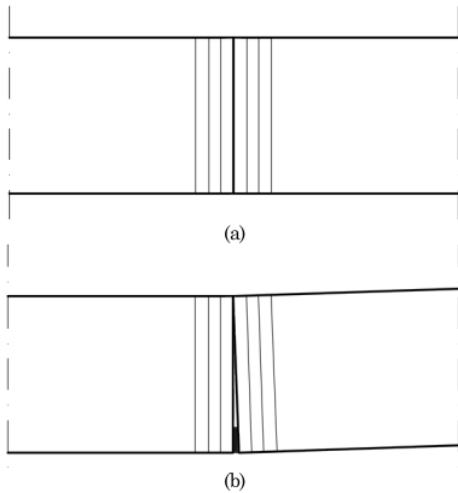
Figure 5. Pile Connection (a) No Gap; (b) With Gap

The first specimen was prepared in such a way that visually there was no gap. There was no special effort to push the two parts of the pile to close the gap. The connection was performed by welding the two end-plates without gap (Figure 5a). Figure 5b shows the second specimen that was prepared with predetermined gap by inserting a 5 mm thick steel plate at one side of the area into the space between endplates. The two endplates of the piles were then welded at four points to tie the end-plates (Figure 5)

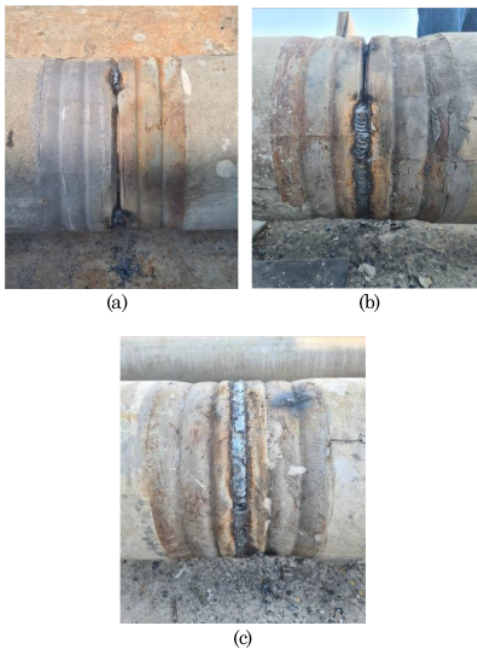
Figure 6. Spun Pile Connection with Gap (a) Welding at Four Points; (b) Welding at Half Circle; (c) Full Welding

First of all, the endplates were welded in four points (Figure 6a), then three layers of welding were applied in a half circle of the splice (Figure 6b). Finally, the splice was welded in full circle in three layers (Figure 6c). The three conditions of the specimen were tested using PIT to observe effect of those change of impedance.

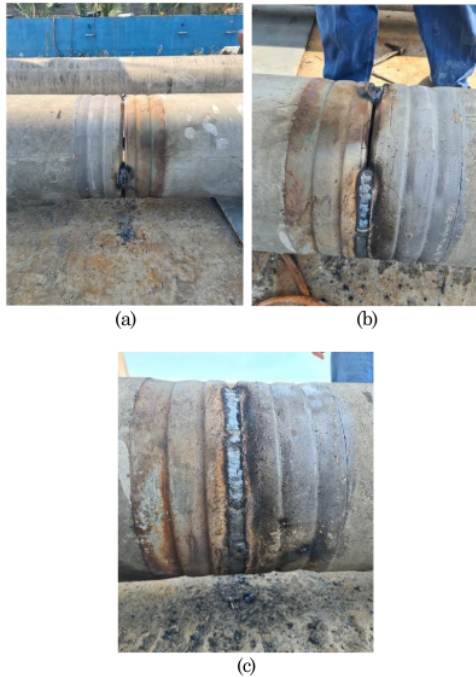
Figure 7. (a) Welding at Four Points; (b) Welding at Half Circle; (c) Welding Full Circle

Similar to the preparation steps for specimen with splice without gap, a 5 mm thick steel plate was inserted into the edge of the two endplates as shown in Figure 7a, then three layers of welding were applied in a half circle of the splice (Figure 7b). Finally, the splice was welded fully in three layers (Figure 7c). The three (3) conditions of specimen were tested using PIT.

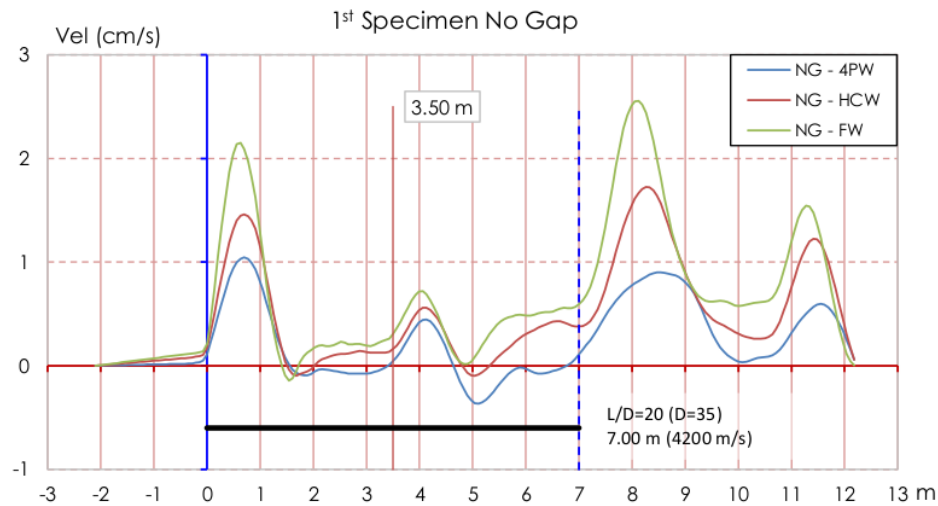
Figure 8. Response of Stress Wave at the Splice with no Gap, which were Welded Together at Four Points (NG – 4PW), Half Circle (NG – HCW), and Full Circle (NG – FW)

The results of PIT on the specimen without gap is depicted in Figure 8. It shows that when the splice of the pile is welded at four points (point welded), the stress wave unable to propagate through the splice; the wave is reflected back. In other words, the pile is assumed exhibits the length of 3500mm. When splice was welded half circle of its periphery, a relatively high spike of response wave (reflecting wave) at the distance of 7000mm (pile toe) was observed. The spike of wave velocity is as high as that of the initial one. When the splice was welded in full circle, the spike of recorded reflection wave

velocity at the distance of 7000mm is higher than that at the impact location. Figure 8 shows that the spike of wave velocity at the distance of 7000mm increases with the welded area at the splice. The spike of reflecting wave velocity at the splice that was welded in full circle might be caused by a gap that still exist between the endplates regardless visually there was no gap noticed. The gap can not be entirely closed since there was no special efforts

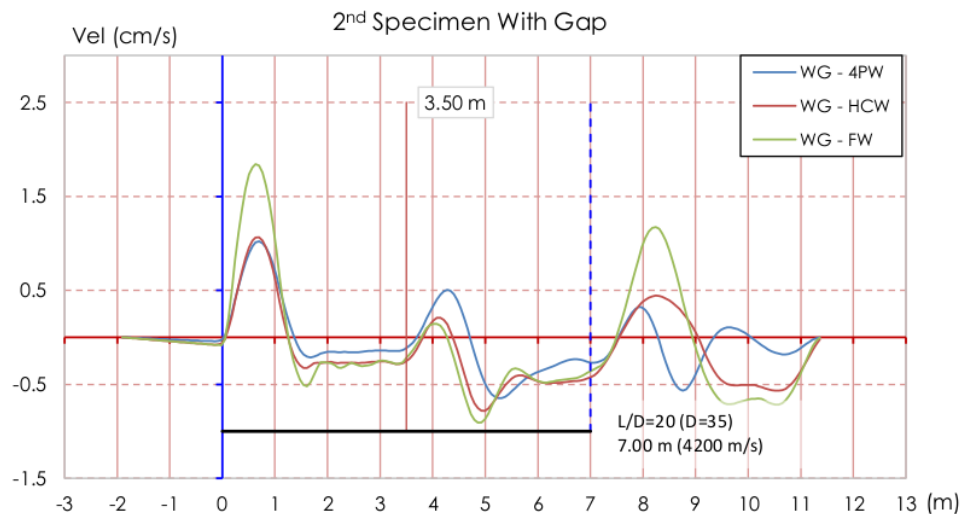
Figure 9. Responses of Stress Wave at the Splice with Gap, which were Welded Together at Four Points (WG – 4PW), Half Circle (WG – HCW), and Full Circle (WG – FC)

The response of recorded travelling wave velocity of the specimen which was connected with a gap at its splice is presented in Figure 9.
