Performance of an Existing Reinforced Concrete Building Designed in Accordance to Older Indonesian Seismic Code: A Case Study for a Hotel in Kupang, Indonesia

Pudjisuryadi, P.^{1*}, Lumantarna, B.¹, Setiawan, R.¹, and Handoko, C.¹

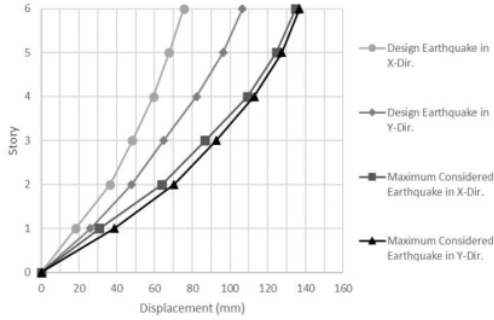
Figure 6. Hotel X Displacement Graph

From the analysis results, story displacements, drift ratios, and member plastic hinge damage levels were recorded. Table 3 summarizes the story displacements and drift ratios of the structure in both directions due to elastic design and maximum considered earthquake levels. The same story displacements and drift ratios are also illustrated in Figure 6 and Figure 7, respectively. Moreover, the performance level limits according to FEMA 356-2000 are also plotted in Figure 7. From Figure 7, it can be seen that the seismic performance of Hotel X according to FEMA 356-2000 is very good. Even when the Hotel X was subjected to MCE, the drift ratio still showed Life Safety Performance level in both directions.
