# ARTEKS

Research paper

## The construction of temporary and permanent housing after the Semeru eruption as a new strategy for post-disaster reconstruction

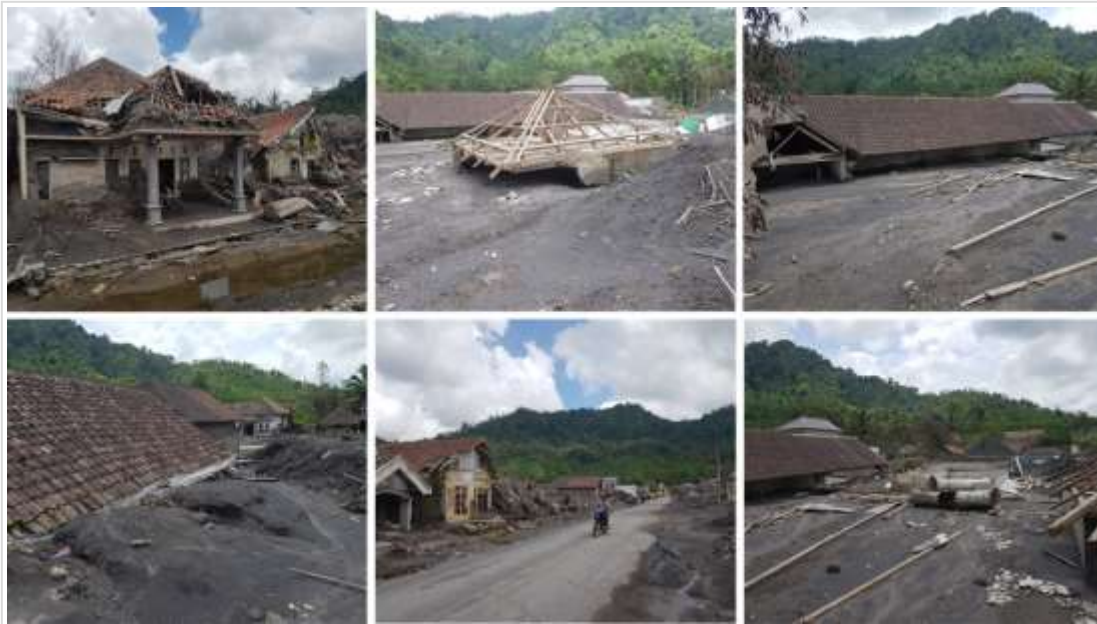
**Figure 1.** Damage caused by the eruption of Mount Semeru in Kamarkajang Village

whose eruptions have been recorded since 1600. Mount Semeru, one of the eight type A volcanoes, experienced an eruption on December 4, 2021 (Hidayat and Ermawati 2022). The impact of the eruption disaster recorded 51 deaths as of December 21, 2021, and 10,395 people were displaced in almost 410 refugee camps (BNPB 2021). The impact of the disaster was damage to facilities and infrastructure, including residents' houses (figure 1).

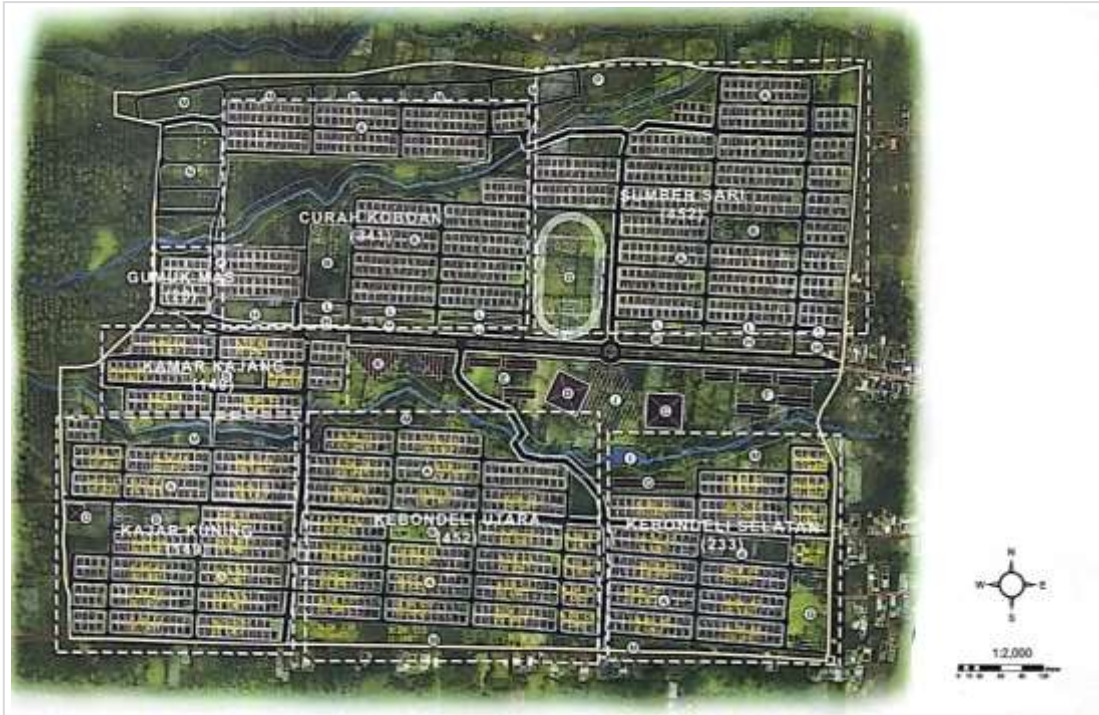
**Figure 7.** Site plan for dividing the temporary housing area  
Source: (Lumajang 2022b)

Minister of Environment and Forestry approved using the Permanent Production Forest area in Lumajang Regency covering an area of  $\pm 90.98$  Ha for Huntara activities for victims of the Mount Semeru eruption natural disaster. This location is in the Sumbermujur Village, Candipuro District (figure 7).

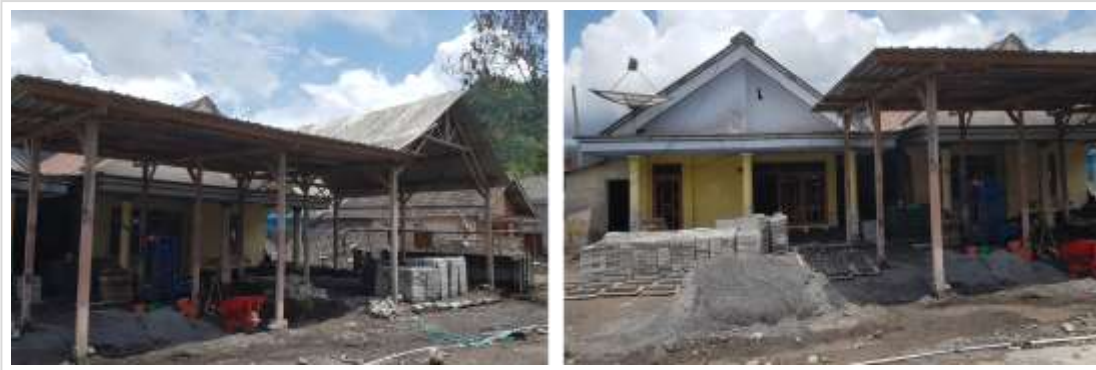
**Figure 8.** Brick-molding small enterprise by the people of Kamar Kajang Hamlet

Contractors carried out the Huntara construction work to meet the criteria and technical specifications in Lumajang Regent Regulation No. 1 of 2022. Contractors carry out various work concerning these regulations, including land improvement, wall frames, roof frames, wall coverings, floors, doors, windows, sanitation, and finishing work. Material procurement prioritizes local materials, especially bricks for walls. This material was molded by local village people using sand from the eruption of Mount Semeru, one of which is a brick-molding small enterprise in Kamar Kajang Hamlet (figure 8).

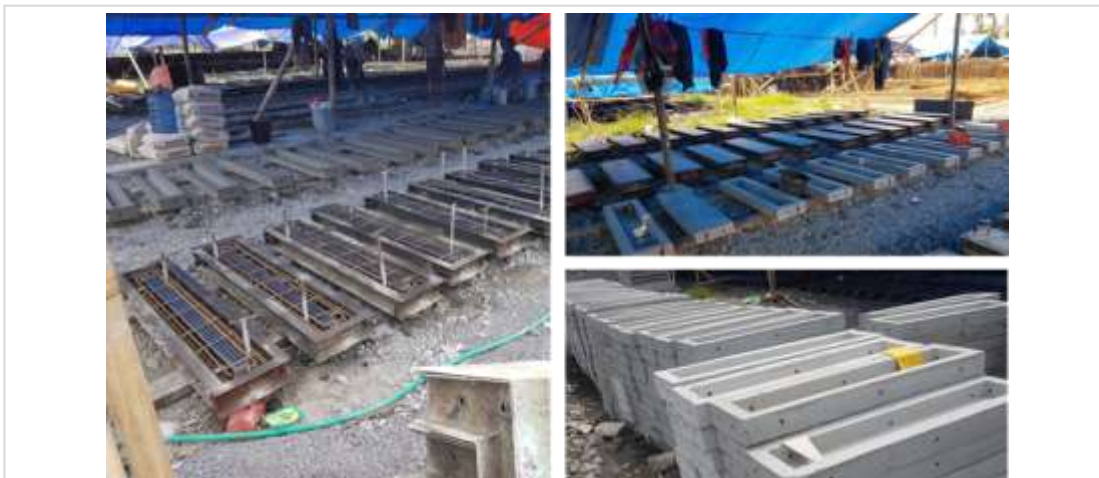
**Figure 9.** In situ precast for Huntap structural elements

namely PT Brantas Abipraya and PT Hutama Karya. Prefabricated concrete structural components are cast at the construction site (precast in situ), as seen in figure 9.

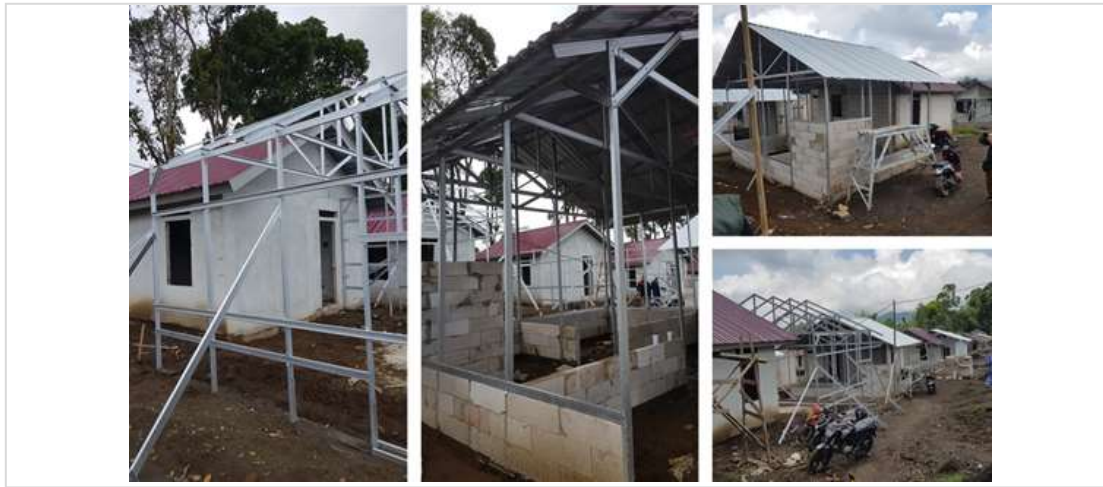
**Figure 10.** The construction of Huntara

site according to [figure 4](#). The building is square, with an area according to regulations, namely 6 meters x 4.8 meters, with a gable roof shape. The rooms provided include 1 (one) bedroom (3 meters x 2.4 meters), 1 (one) bathroom (1.5 meters x 1.5 meters), a multipurpose room, and a terrace. The materials used follow regulations; for wall materials, use brick and Calsibord with a galvalume frame with a total wall height of 3 meters ([figure 10](#)).

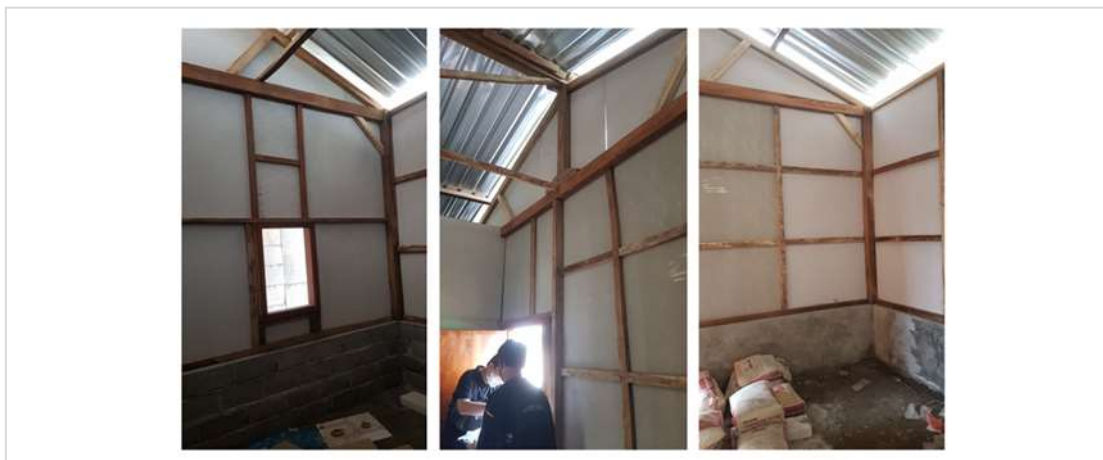
**Figure 11.** The construction of Huntara's wooden frame

donor built Huntara with a wooden frame of Meranti for wall and roof frames ([figure 11](#)). Red Meranti wood (*Shorea Shorea leprosula* Miq.) is classified as class III wood ([Wahyudi and Sitanggang 2016](#)). So, using meranti wood does not violate the Regent's Regulations.

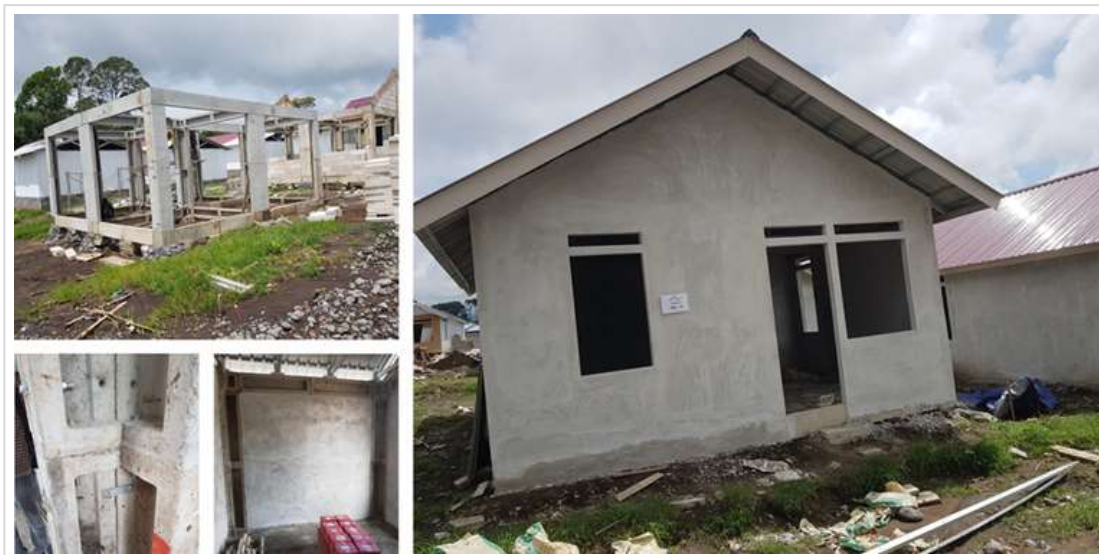
**Figure 12.** The construction of permanent housing (Huntap)

Using the RISHA concept, BUMN carries out the construction of permanent housing (Huntap) under the Ministry of Public Works and Public Housing (PUPR) coordination. From observations, the Huntap built in Sumbermujur Village is a square measuring 6 meters x 6 meters with 4 (four) modules. The size of the module is 3 meters x 3 meters. The structural frame on the walls is made of precast concrete components (figure 12), with the filler walls being lightweight concrete 7 cm thick. The roof is gable-shaped with a light steel (galvalume) roof frame and a spandex metal roof covering. The unit's

placement on the site follows Lumajang Regent Regulation No. 1 of 2022, namely, in front of the Huntara. The front of the permanent housing unit faces the neighborhood road, and the room provided includes 2 (two) bedrooms 3 meters x 3 meters, a multi-function room, and a bathroom 1.5 meters x 1.5 meters. The walls are finished with plaster, and the floors are covered with ceramics. The construction implementation follows the RISHA guidelines from the Center for Settlement Research and Development (Puslitbangkim) Ministry of PUPR prepared by (Sabaruddin and Sukmana 2015).

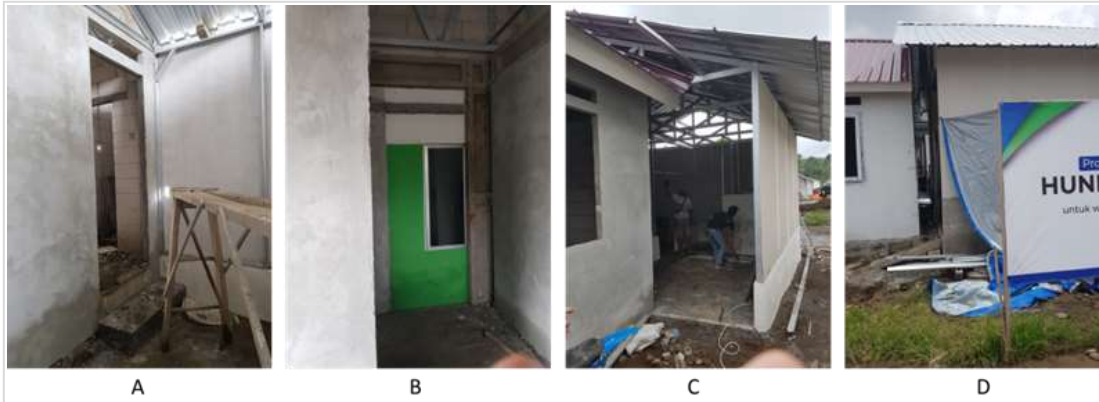
Figure 13. Problems in integration of the two housings

following: (1) Difference in floor levels at the two building unit junctions (figure 13A); (2) The door and or window openings in the Huntara meet the massive walls of the Huntara so that the two building elements in the Huntara do not function

(figure 13B); (3) Meeting roof planes that are not correctly connected (figure 13C); (4) A wide gap at the meeting of the Huntara and Huntap units (figure 13D).

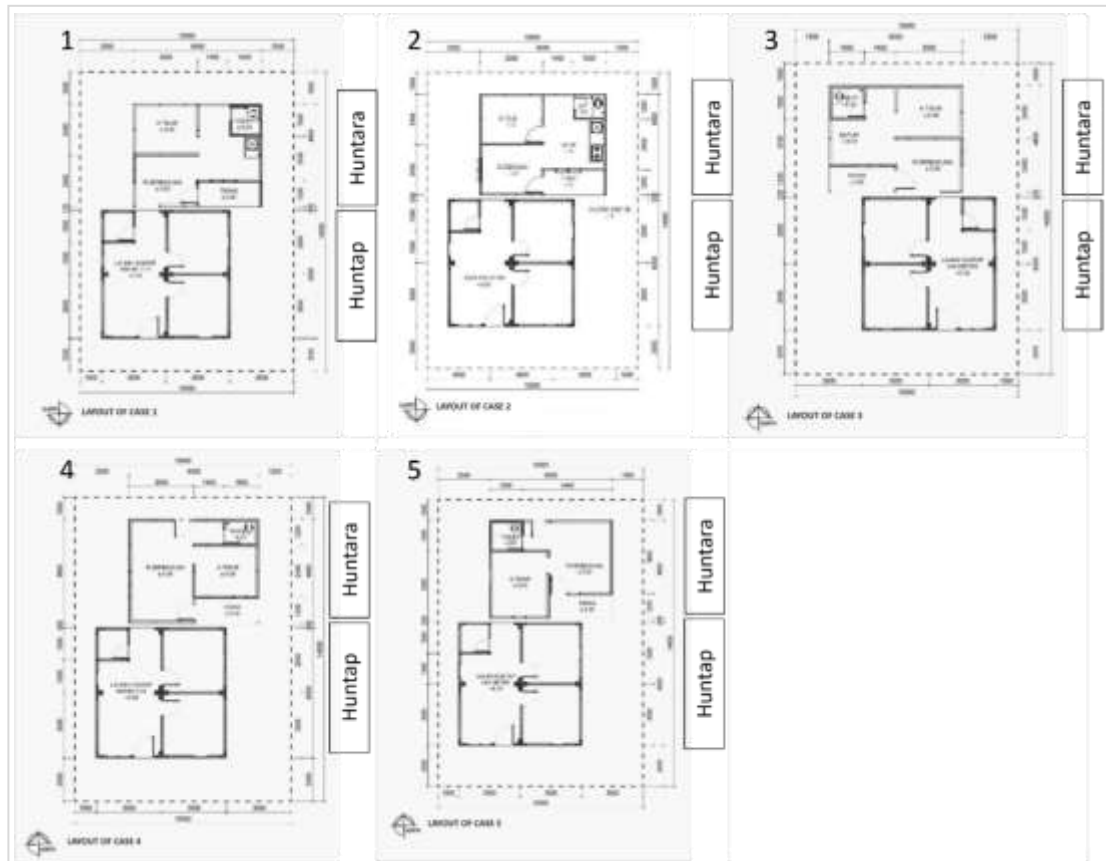
**Figure 14.** Layout of Huntara and Huntap for cases 1 to 5

Figure 14 shows the layout of the combined Huntara and Huntap plans in five cases. Researchers found three things from this data. The first discovery was a gap with varying distances between the Huntara and Huntap units. The second finding was that there were four cases of door and window openings in the Huntara meeting massive walls in the Huntara building, so

both building elements in the Huntara needed to be fixed. The third finding is that the spatial layout in Huntap is the same in each case. Still, in Huntara, there are several differences, namely connecting access between the two units, the back door, and the kitchen/pantry table (see also table 1).
